Beaver Valley East Landfill Evaluation

PREPARED FOR: David Guier, LyondellBasell
Jane Patarcity, Beazer East, Inc.

PREPARED BY: Cheri Salas, CH2M HILL

DATE: September 2, 2008

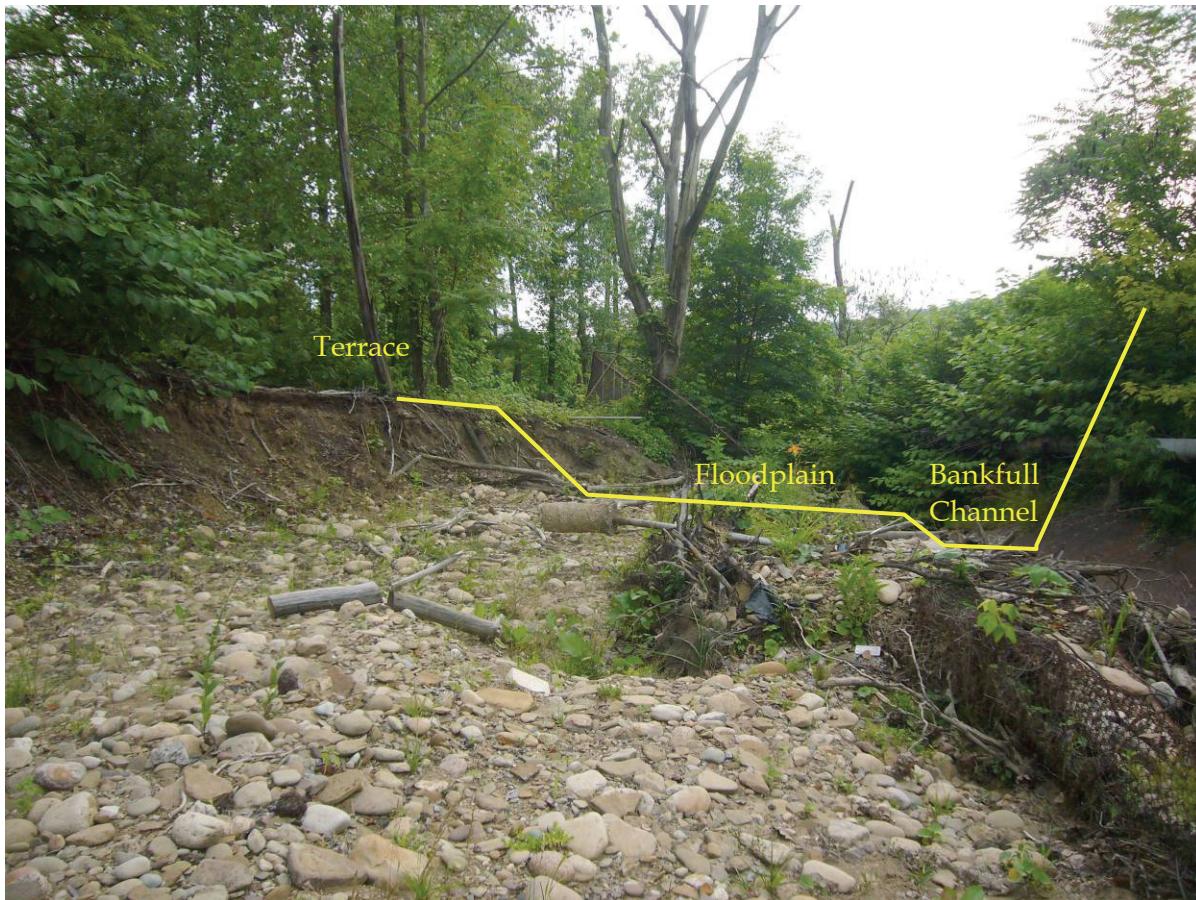
PHOTO 1
Typical Channel Cross Section

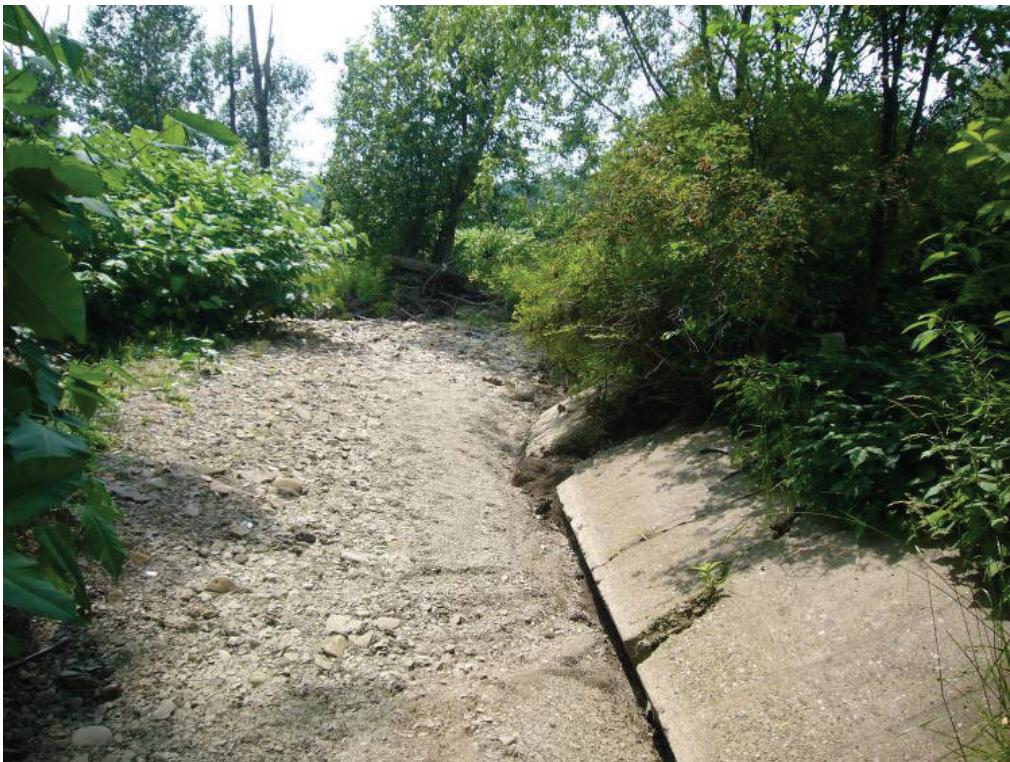
PHOTO 2

Channel undermining concrete stabilization upstream of site, adjacent to the dewatering ponds

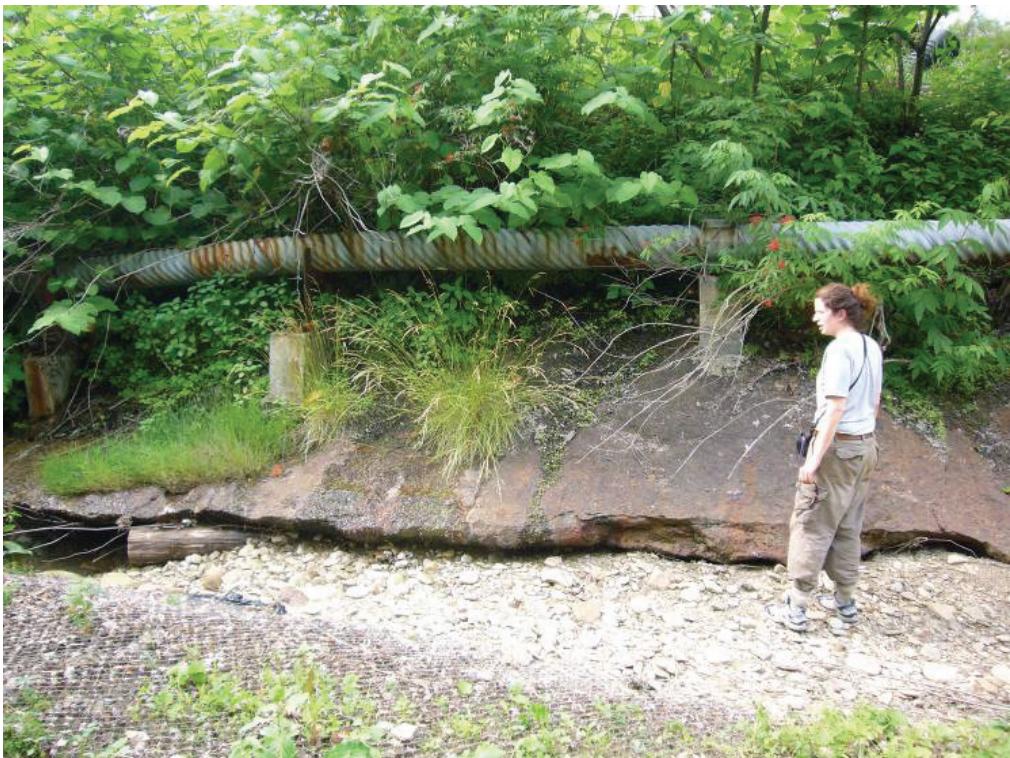
PHOTO 3

Channel undermining rock downstream of site, on adjacent property

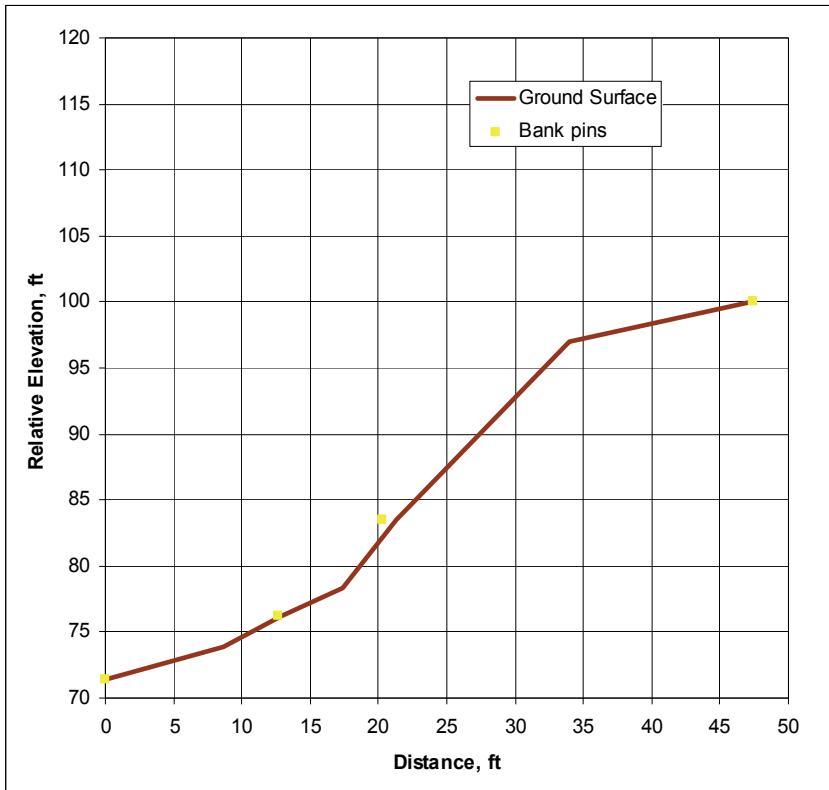
FIGURE 2
Eroded Embankment Profile

The embankment of concern is a land slope that has been eroded as the channel has eroded through the terrace. It is located approximately 25 feet from the bankfull channel. At the highest point, the eroded slope is approximately 30 feet high and consists of loose sand and gravel. During the site visit, the embankment was extremely dry, with cohesionless soils. Figure 2 provides a cross section of the most extreme point of erosion. The erosion scar extends approximately 100 feet (longitudinally along the embankment) to the points where it intersects the 4-foot terrace on both the upstream and downstream sides. The terrace also shows signs of erosion (Photo 4), indicating the channel may still be widening. The erosion has created a 75-foot gap in the security fence on the top of the terrace. Photos of the existing conditions of the channel are provided in Attachment D.

Current site conditions indicate that the cause of the erosion is undercutting of the toe during flood flows involving overbank flow conditions. The stream channel is located in a valley, approximately 30-feet below the toe of the East Landfill. There is a series of dewatering ponds on the adjacent property (Figure 1) that appear to have been constructed in the stream valley, within the former floodplain of the channel. Based on the USGS Topographic Quad Map, the ponds have been in existence since at least 1983. The exact date of installation for these ponds could not be determined from available data. The steep slope from the LyondellBasell property and the dewatering ponds appear to have created a pinch point (i.e. a constrictive narrowing) in the floodplain. As high flows approach the area adjacent to the eroded embankment, the flow width narrows, and flow depth and velocity increase. At this location, the flow velocities are directed toward the eroding embankment as it turns to flow into the straightened segment. The sheer stresses resulting from the higher flow velocities and flow redirection appear to have caused the eroding embankment. Additionally, the berms from the ponds were likely constructed of compactable material that would prevent erosion, placing higher pressure on the more erodible embankment on the property.

If additional erosion does occur, the toe of the slope could be stabilized with rock of sufficient size / gradation, or other optional materials to arrest the erosion, and the upper embankment can be revegetated. Consideration should be given to the potential consequential impact to adjacent portions of the embankment to prevent the erosion from migrating further downstream after stabilization.

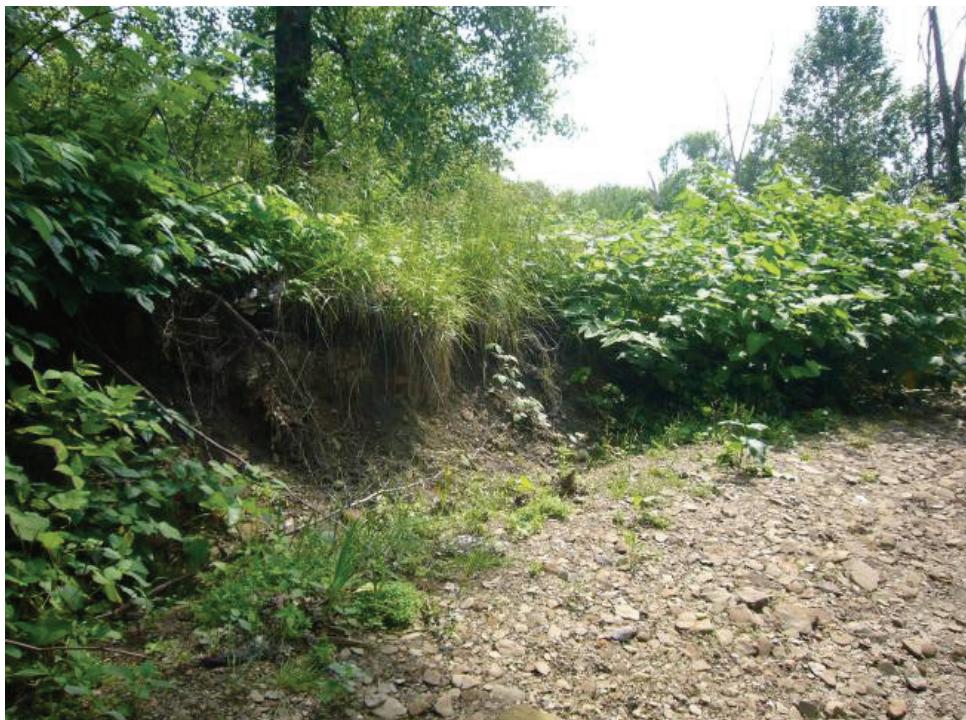
Based on site observations, the channel adjacent to the East Landfill is not stable. It appears to have cut down creating a terrace (cutwall) 4-feet above the thalweg (lowest point in the channel) and has begun to widen to create a new floodplain (Photo 1). Concrete channel stabilization upstream and downstream of the site is being undermined (Photos 2 and 3), confirming the active down cutting of the channel. This stabilization is located outside the security fence, on the opposite side of the stream channel, and based on discussions with Lyondell, it is believed to be on the adjacent property. A brief watershed analysis is provided in Attachment C.

PHOTO 4
4-foot terrace upstream of site

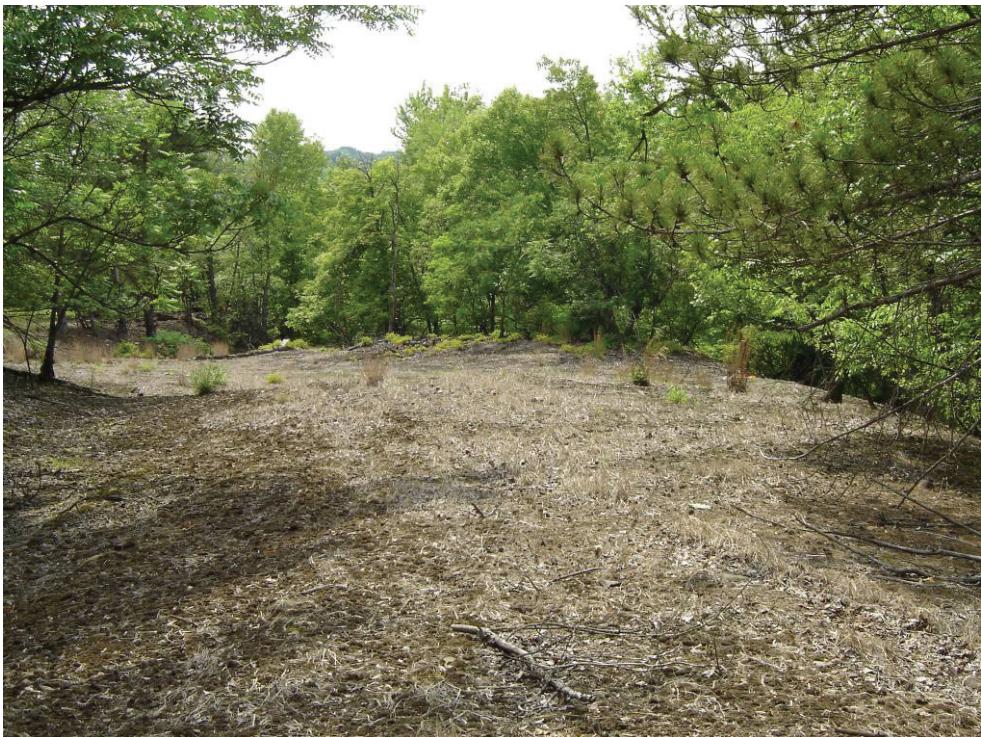
PHOTO 5
Sparsely vegetated area

The results of this evaluation do not provide a conclusion as to the cause of the sparse vegetation. Based upon field observations and available disposal area information, the area with sparse vegetation is located approximately 150 feet from the estimated limit of the landfill cap, and over 200 feet from the closest known disposal area. Our understanding is that the landfill was capped and vegetated over 20 years ago providing for sufficient time for natural vegetation to recolonize in the area. The absence of vegetative growth in this area cannot be explained without gathering additional data on soil conditions and potential vegetative stressors.

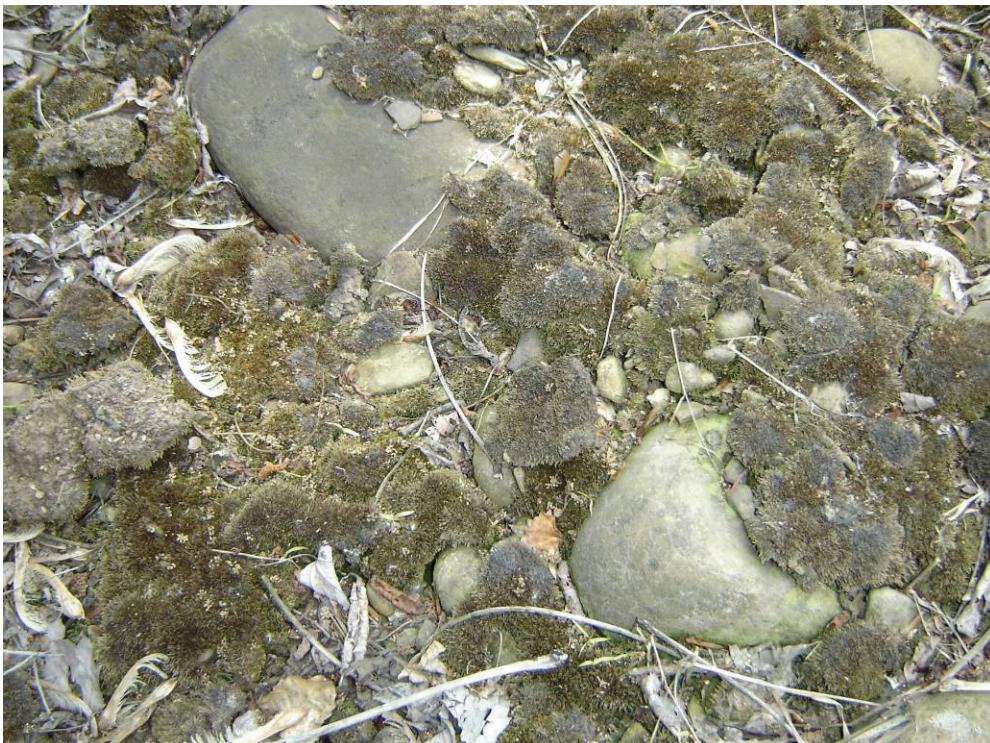
PHOTO 6
Moss observed in sparsely vegetated area

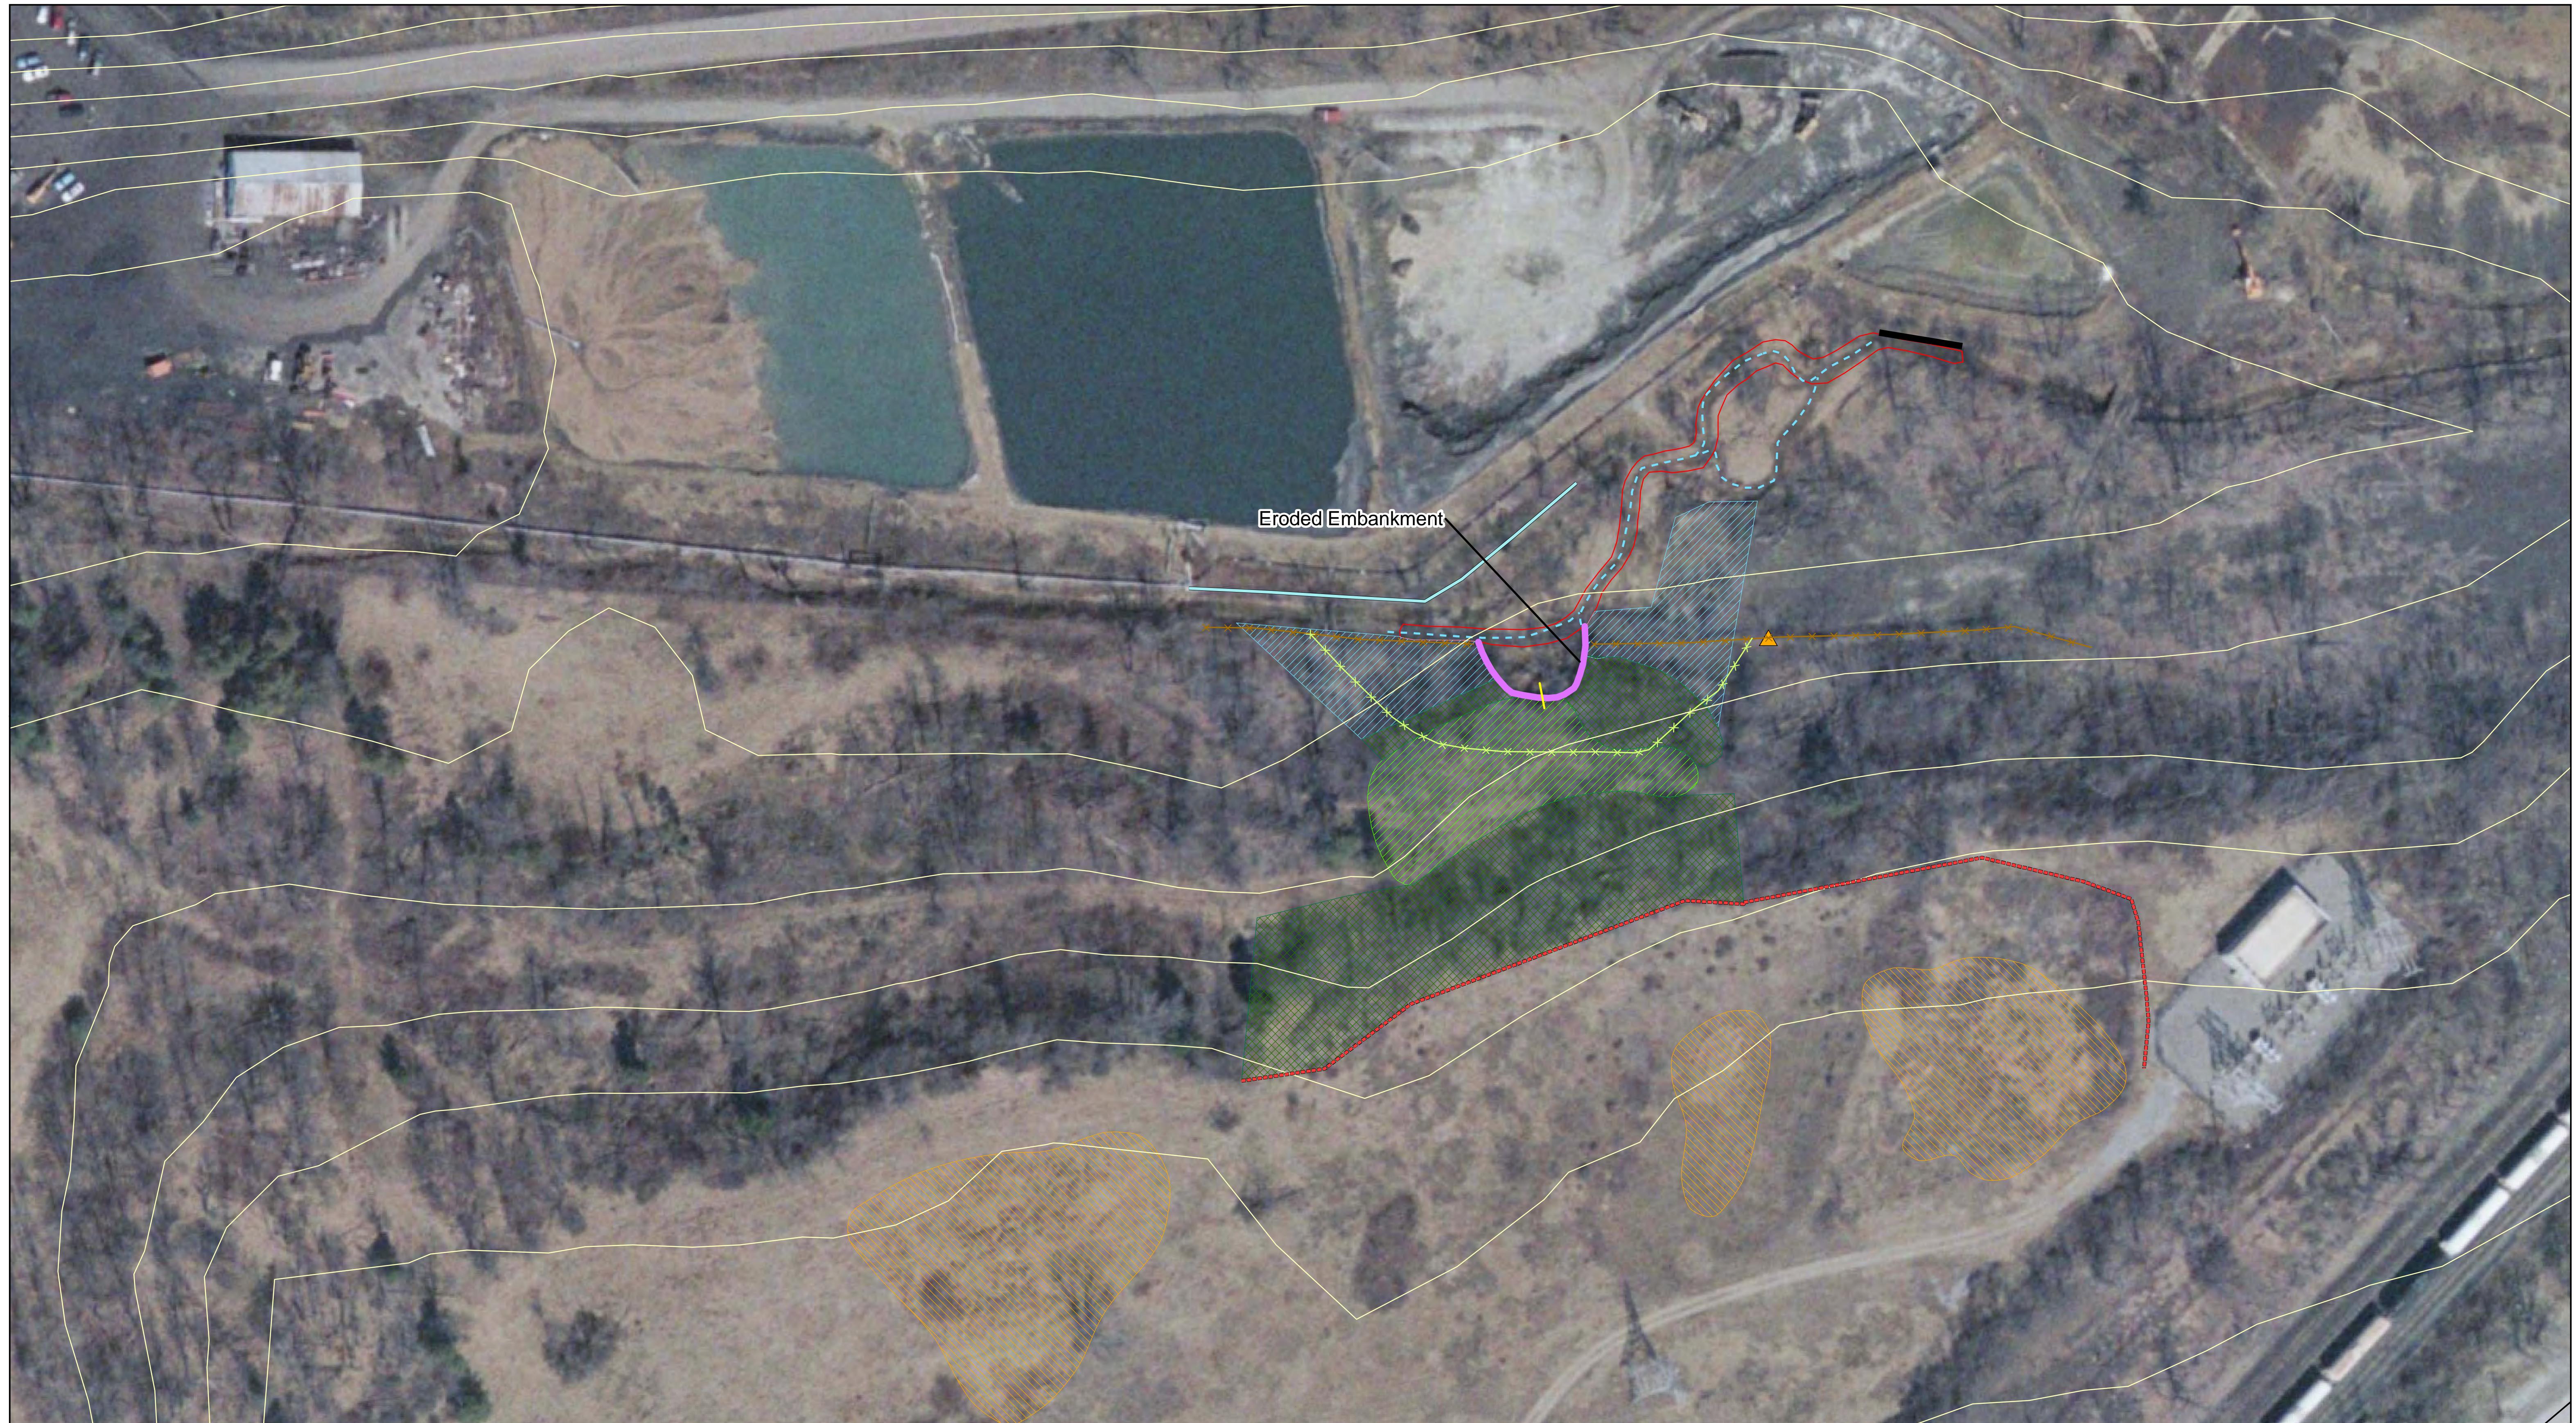
Figure 1
Site Map with Field Notes
LyondellBasell Beaver Valley East Landfill

CH2M HILL staff conducted a site visit on June 25, 2008, to confirm and document that the eroded embankment is not impacting the East Landfill. Figure 1 provides an annotated aerial photo that illustrates the extent and location of the eroded embankment, the security fence failure, and the area of sparse vegetation relative to the East Landfill. It is assumed the East Landfill cap extends to the top of the slope. The only known waste areas are the phosphate sludge dewatering pits, shown in Figure 1. The locations of these pits were digitized from a site map provided by LyondellBasell during the initial site visit in October 2007 (Attachment B).

Based on field observations, the eroded embankment is located approximately 150 feet from the estimated limit of the cap, and approximately 230 feet from the closest known disposal area.

- 1) Replace the security fence. This will require rerouting the fence up to the top of the slope and across the unvegetated area. A new fence alignment is proposed in Figure 1. This will require installation of approximately 400 feet of fence. The estimated fence replacement costs are \$14,000–\$30,000. Cost estimation details are provided in Attachment G.
- 2) Monitor the erosion area annually to confirm the erosion is not threatening the landfill. Use the monitoring site that was installed during the site visit.
- 3) No action is proposed for the sparsely vegetated area because it is outside the limits of the East Landfill.

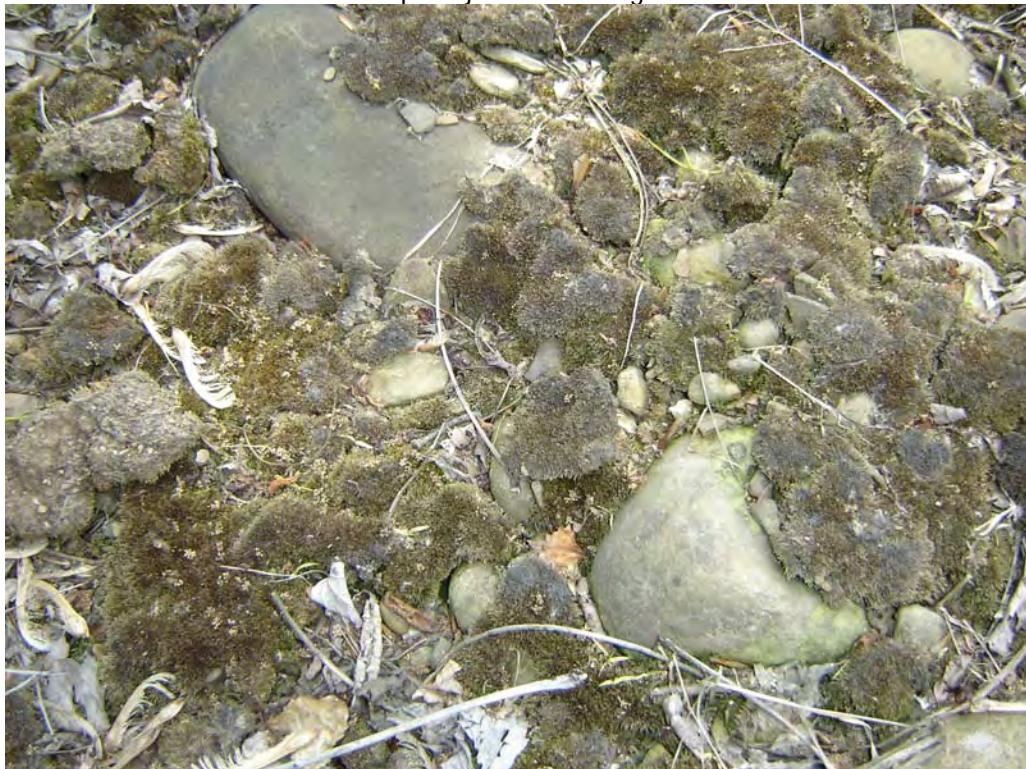
Close-up of soils and moss cover in unvegetated area

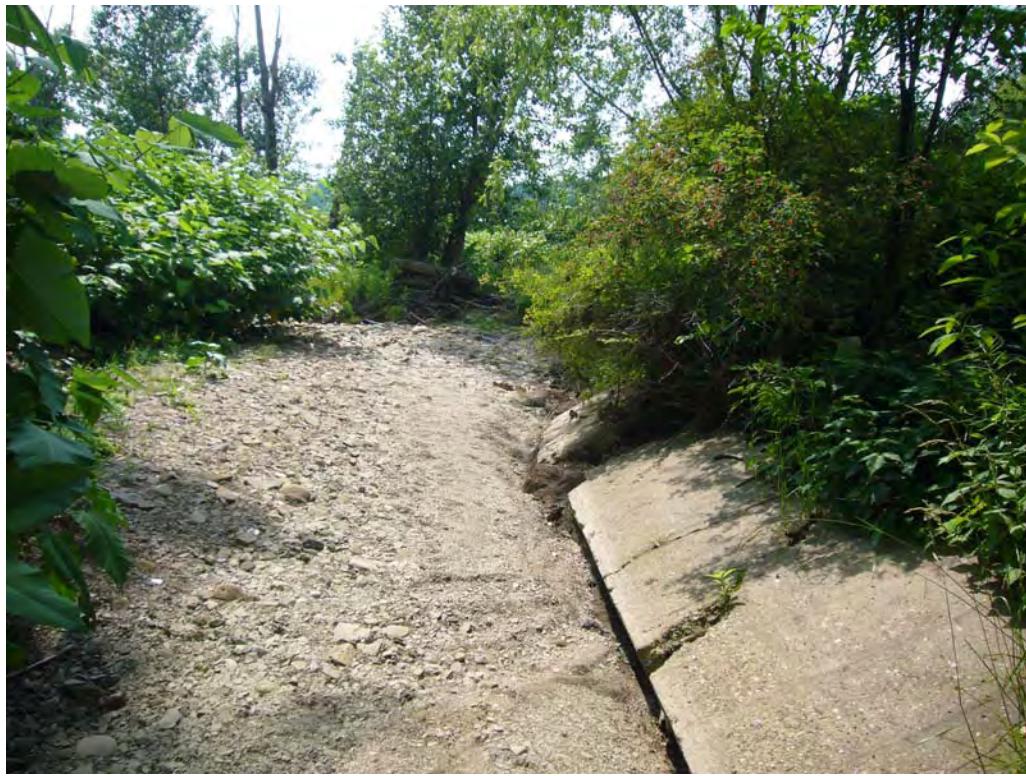
Concrete stabilized stream bank, upstream of site, looking downstream

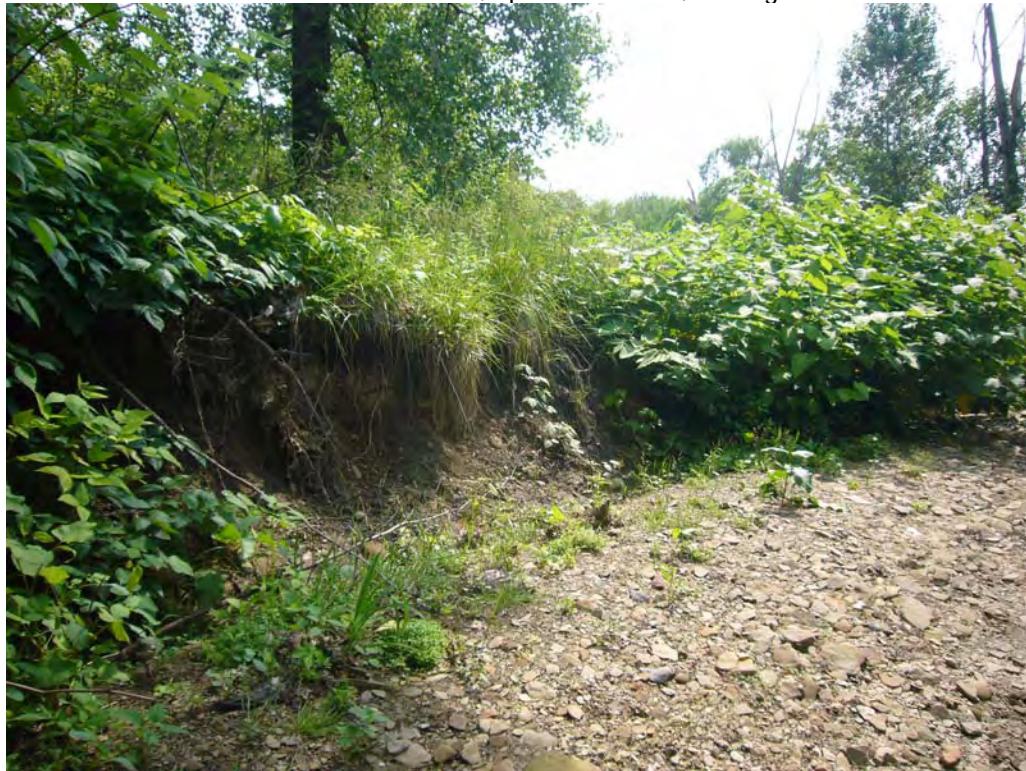
Eroded terrace slope, upstream of site, looking downstream

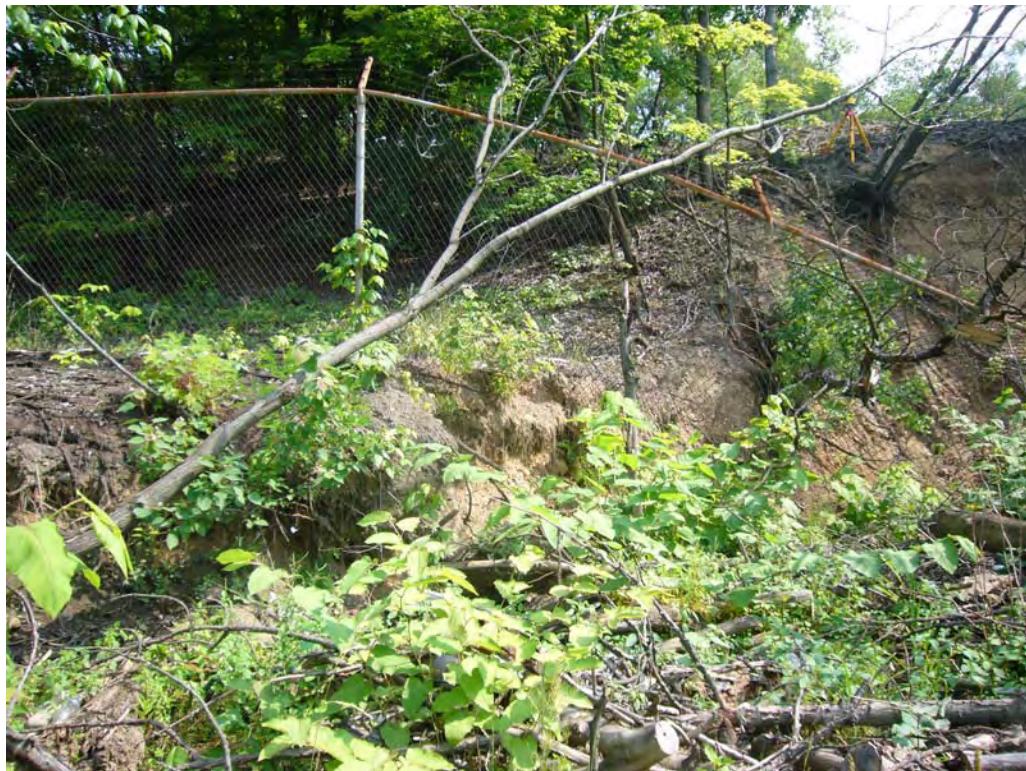
Failed security fence on terrace, upstream side

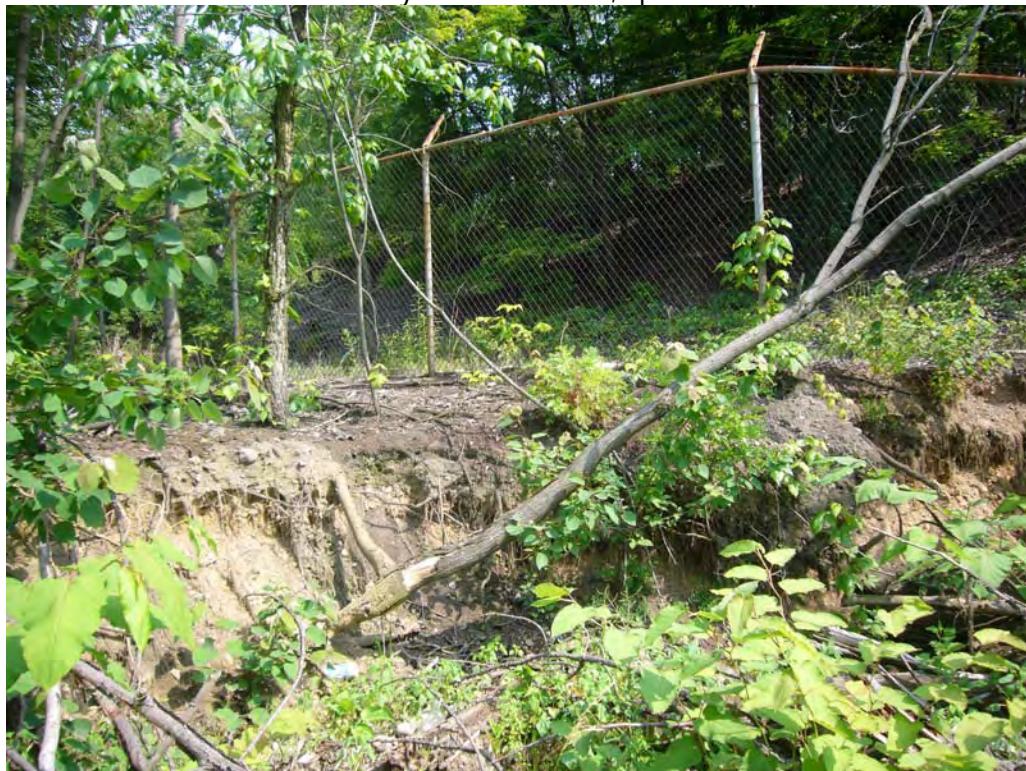
Failed security fence on terrace, upstream side

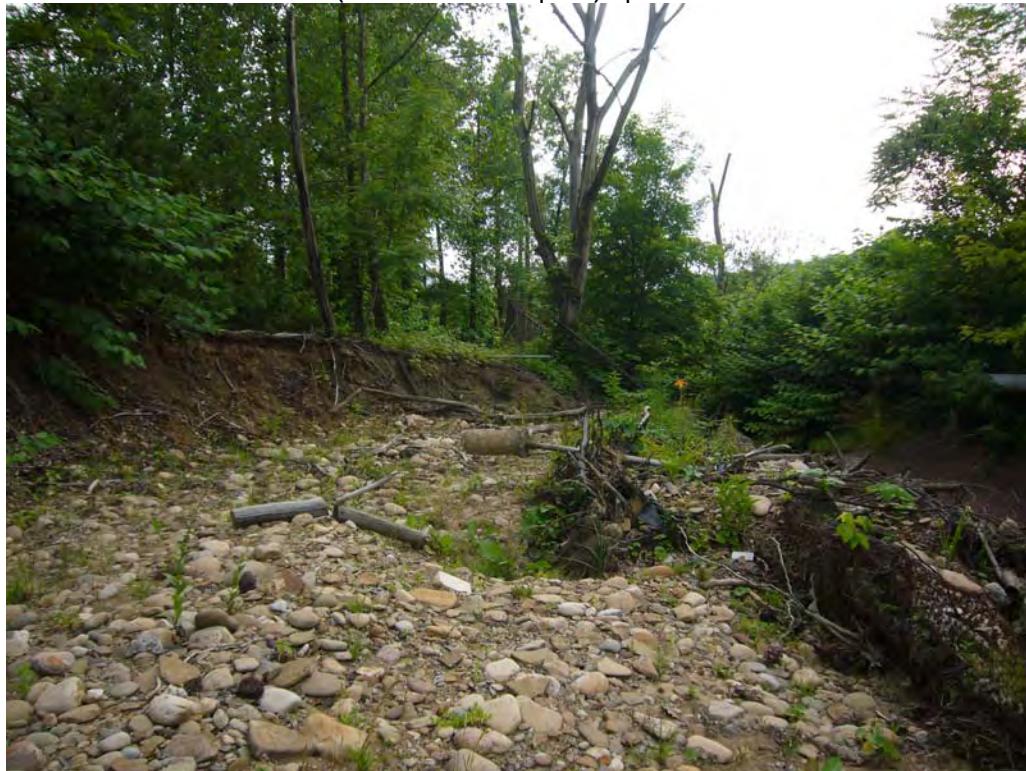
Eroded terrace slope downstream of site, (downstream end of failed security fence)

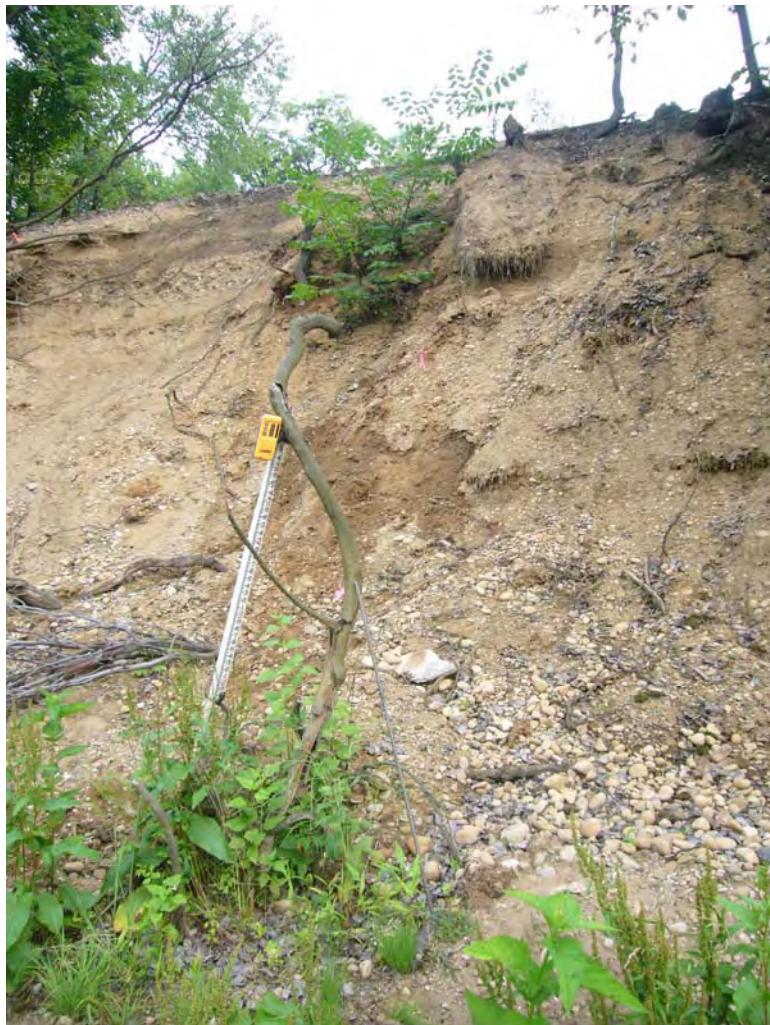
Eroded embankment

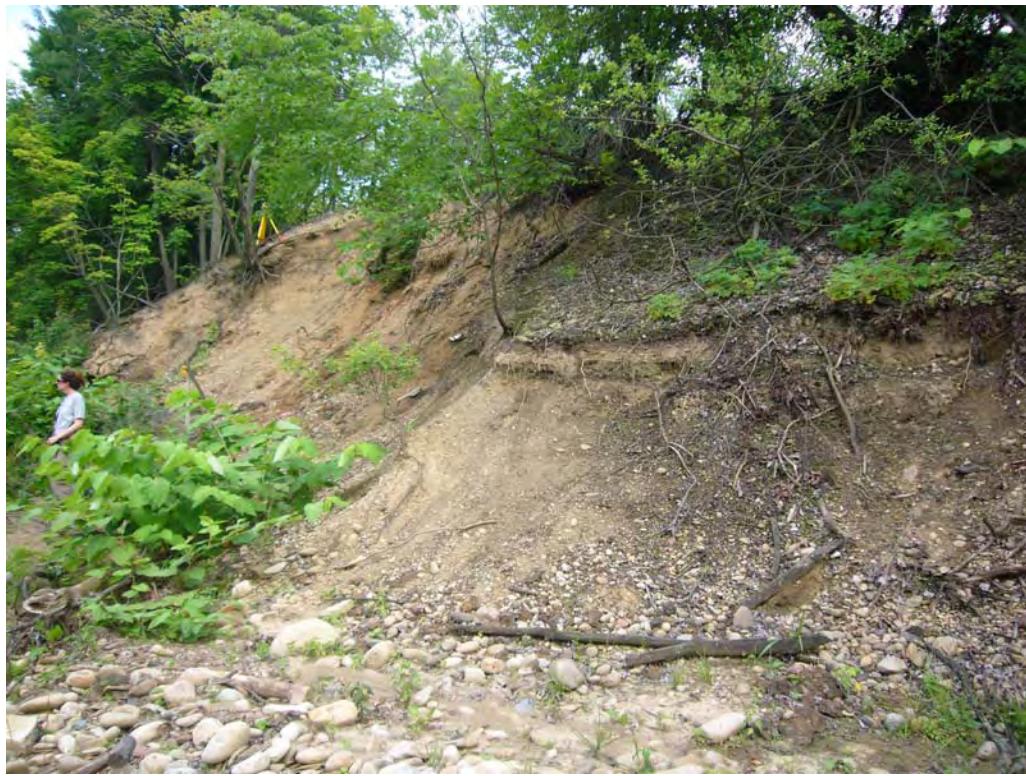
Eroded embankment, looking upstream

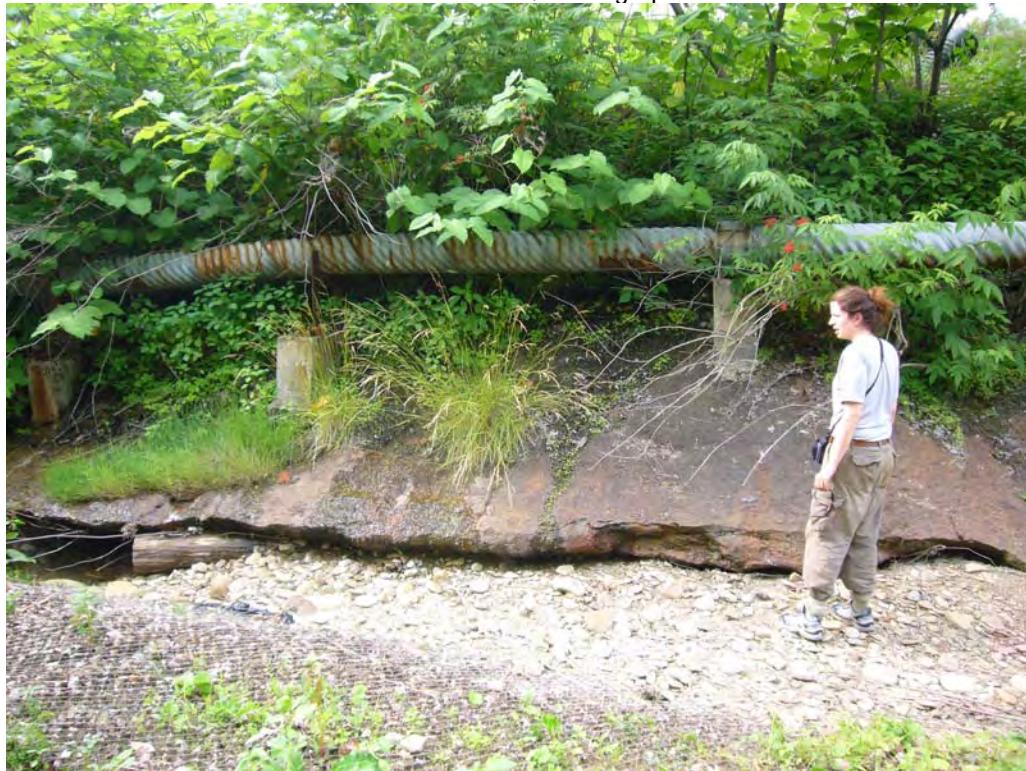
Channel undercutting Rock layer, downstream of site.
